# Manhole Inspection Summary

Manhole # S33EE1014MH

Insp Date: **3/6/07 1:01 PM**

**Location** Address: **3800 39TH ST**

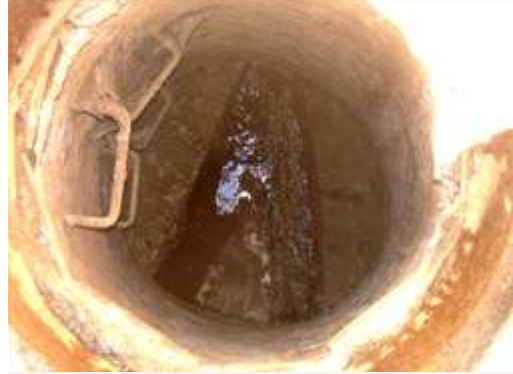
Top View

☒ **Leaks**

Condition: ☐ Sound ☐ Cracked ☐ Root Intrusion ☐ Loose Brick ☒ **Deteriorated**

Infiltration: ☐ None ☒ **Joint** ☐ Cracks ☒ **Mortar** ☐ Roots ☐ Wall

Frame leaks. Adjustment deterioration and infiltration. Bench and Channel debris.

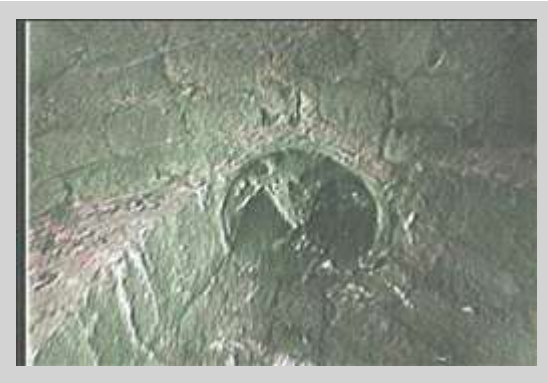
### 8 in. Circular Gravity Sewer Pipe Out @ 12 O'Clock

Condition: ☐ Sound ☐ Cracked ☐ Root Intrusion ☐ Loose Brick ☒ **Deteriorated**

Infiltration: ☐ None ☐ Joint ☐ Cracks ☒ **Mortar** ☐ Roots ☐ Wall

Barrel deterioration and infiltration.

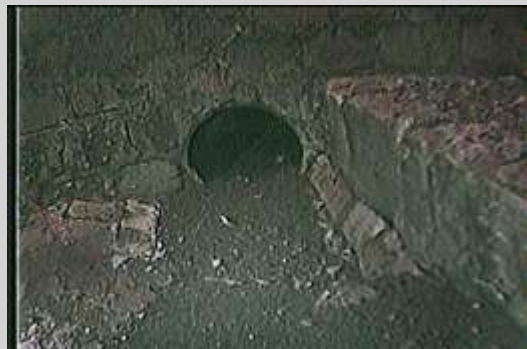
Pipe In @ 6 O'Clock

Channel debris.

Deposits: ☐ None ☒ **Mud** ☐ Sludge ☒ **Debris** ☐ Grease

Silt Depth: **2** (in.)

Deposits Extent: **Medium**

Pipe Seal Cond: **Cracked**
